**REMEDIAL INVESTIGATION
PHOTOGRAPH ALBUM
OPERABLE UNIT NO. 9 (SITE 65)**

**MARINE CORPS BASE,
CAMP LEJEUNE, NORTH CAROLINA**

CONTRACT TASK ORDER 0312

JULY 20, 1995

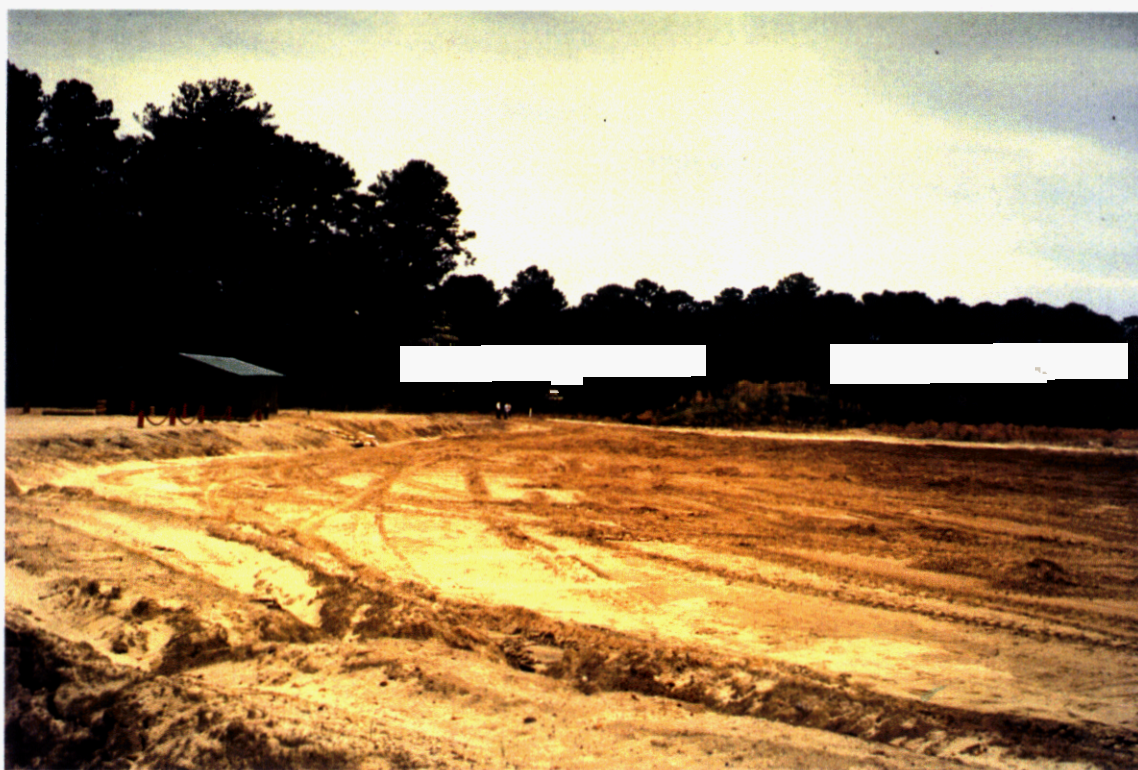
OU9.SITE65.1994.1 View facing northwest across the southern edge of the engineers' training area. The small building seen on the left is a classroom and shelter for students of the heavy equipment training school. A potentially contaminated soil pile is in the background. Additional debris piles are located further west of this building.

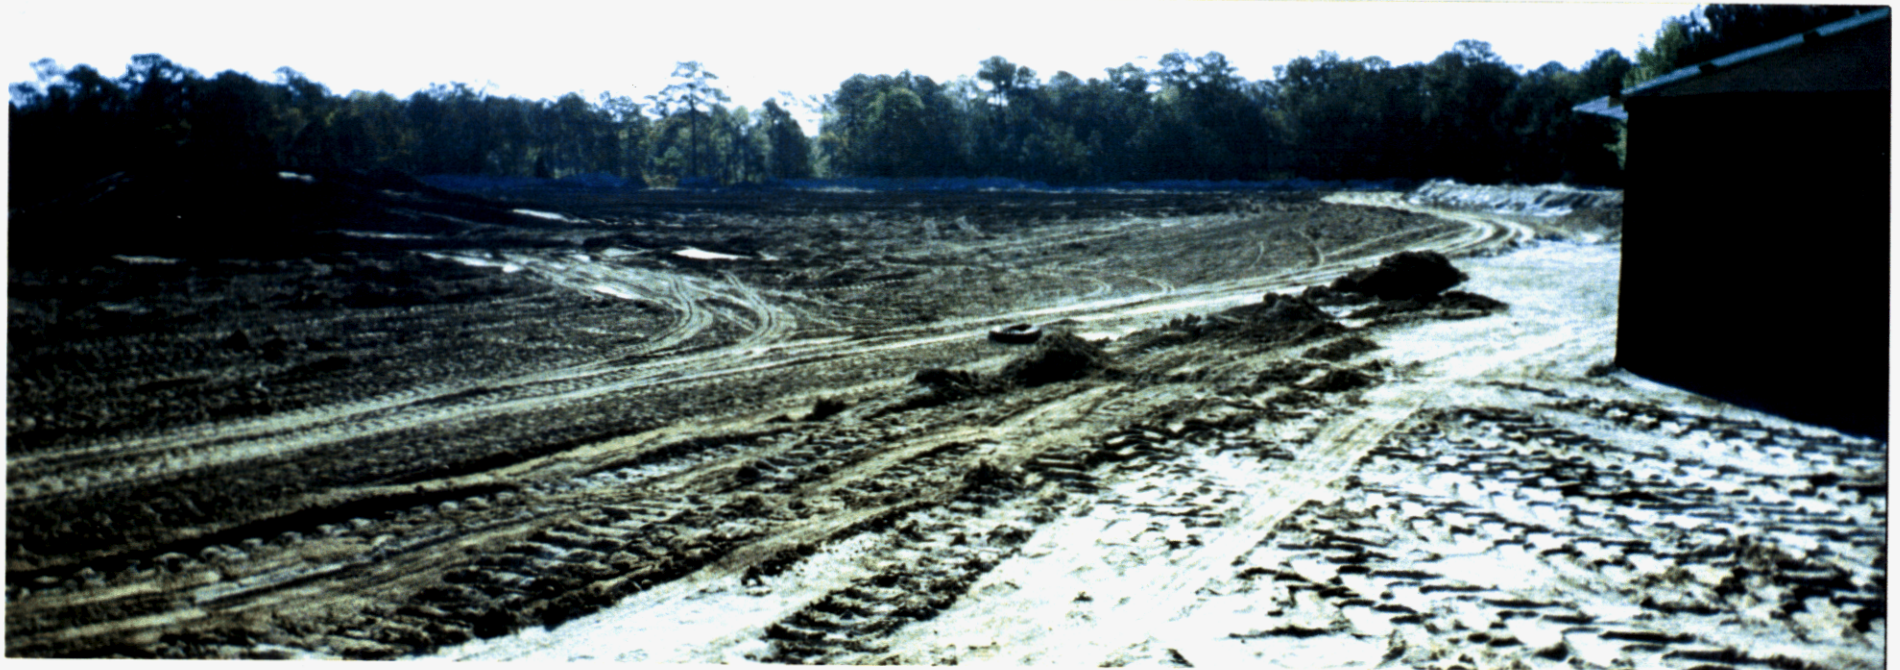
OU9.SITE65.1995.2:

Panoramic photograph of the engineers' training area. View is facing east towards the entrance to Site 65 off of Sneads Ferry Road. This panorama is continued on the next two pages.

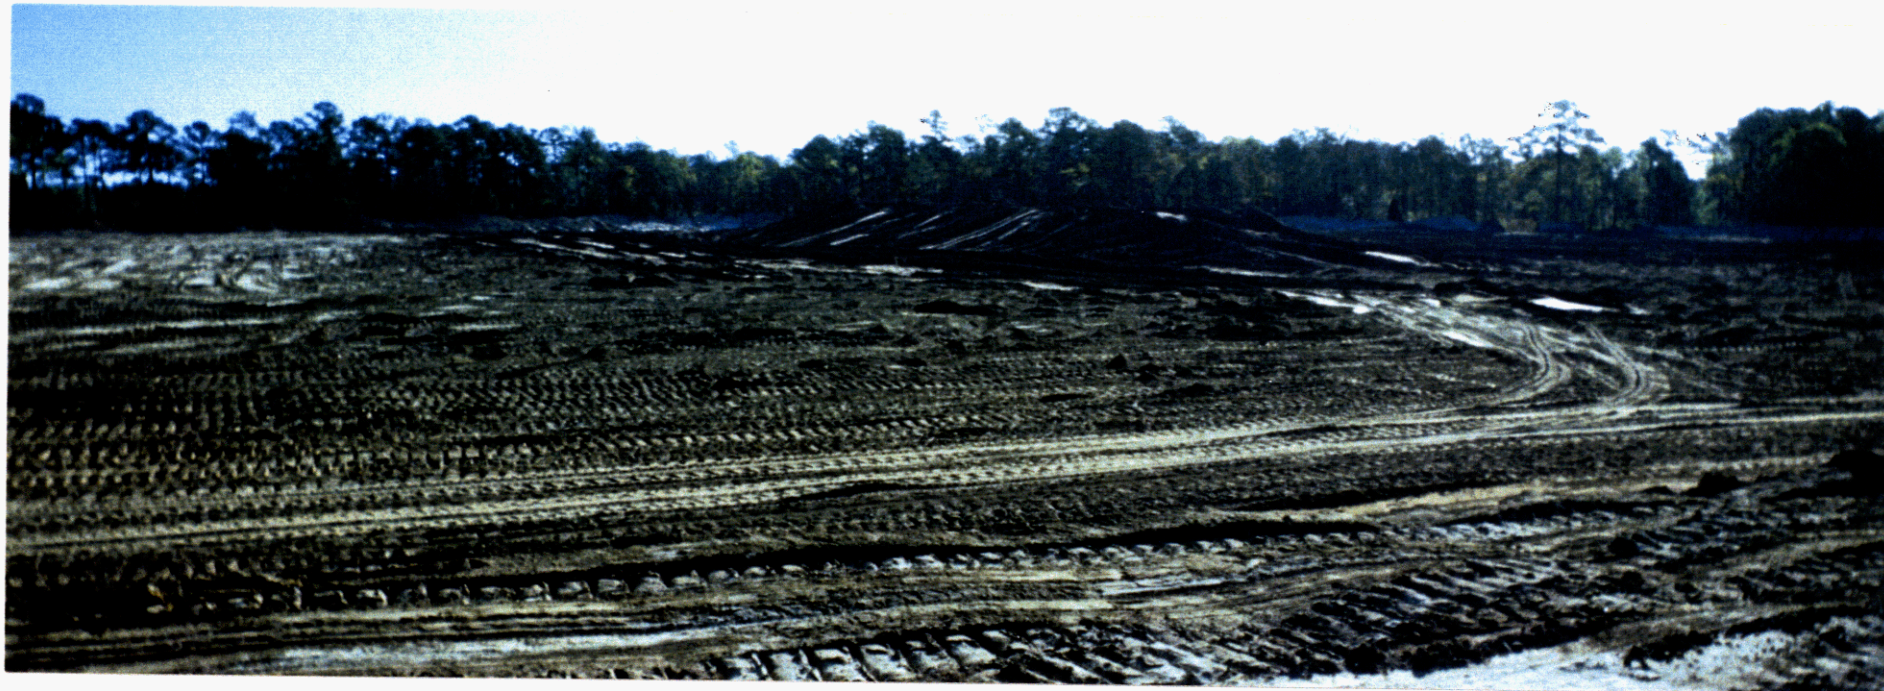
OU9.SITE65.1995.3:

Panoramic photograph continued of the engineers' training area located adjacent to the focus of the Site 65 investigation. This view is facing northeast towards Sneads Ferry Road looking at the center of the training area.

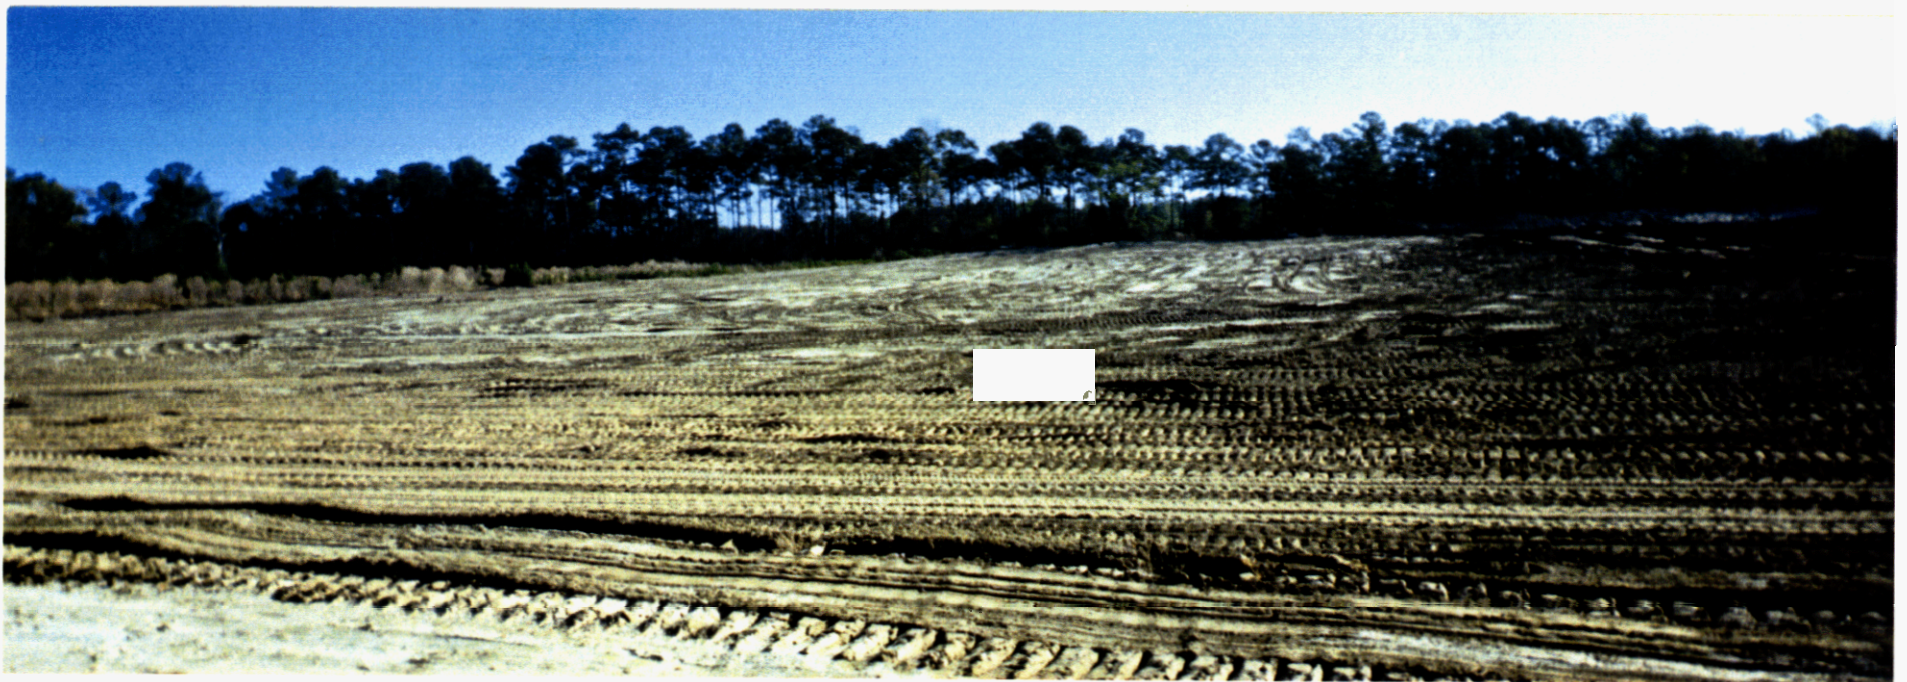
OU9.SITE65.1995.4:

Panoramic photograph continued of the engineers' training area. View facing north.

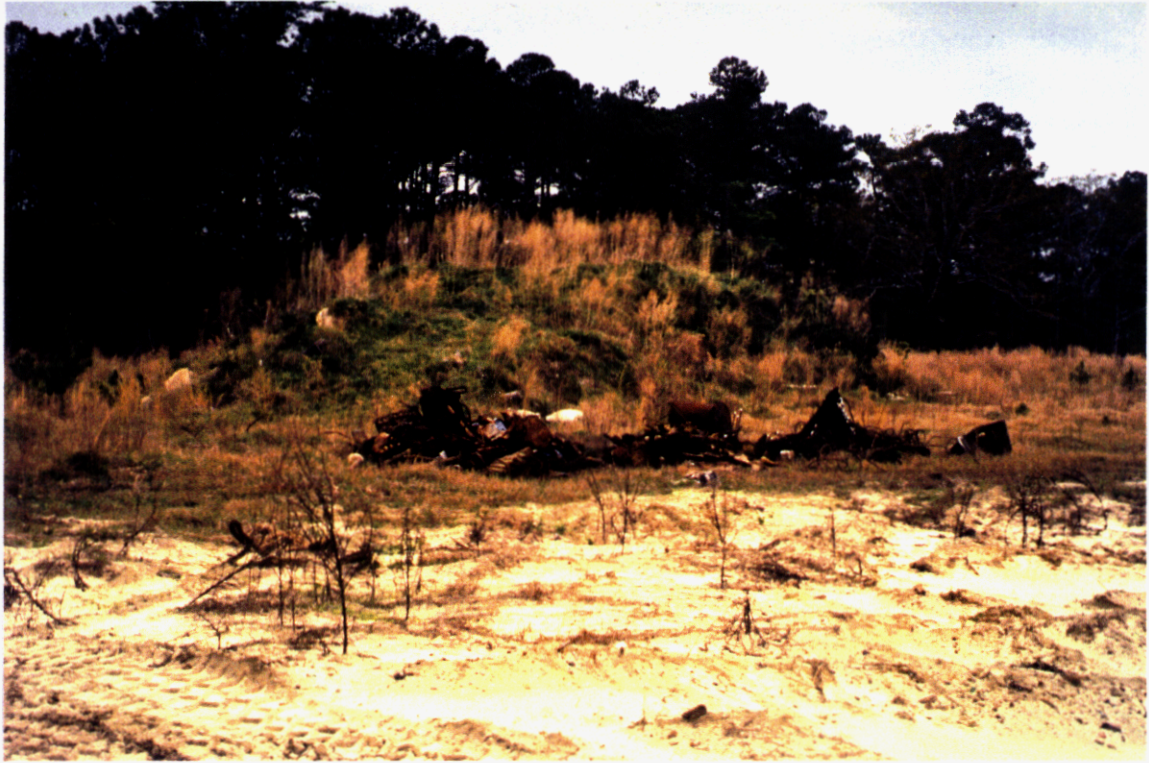
OU9.SITE65.1994.5: Photograph of a large soil mound / possible debris pile which existed on the western edge of the heavy equipment training area until its removal by base personnel in April 1995. The mound was located in the northern portion of Site 65. The visible metal debris was also removed from this location. View is facing north/northwest.

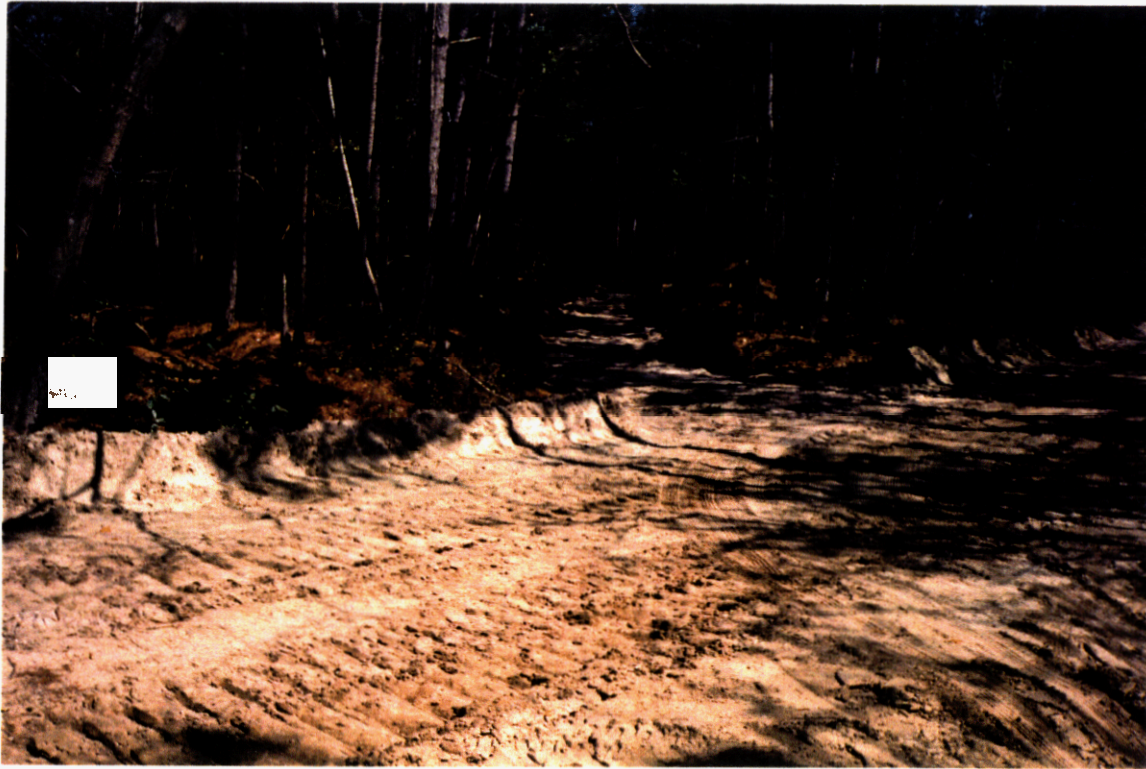
OU9.SITE65.1995.6: Photograph facing north up a small trail which leads to the southern-most debris piles and the burn area. This view is from the same location as photograph No.6, but facing in the opposite direction. The debris piles lie to the left of this photograph.

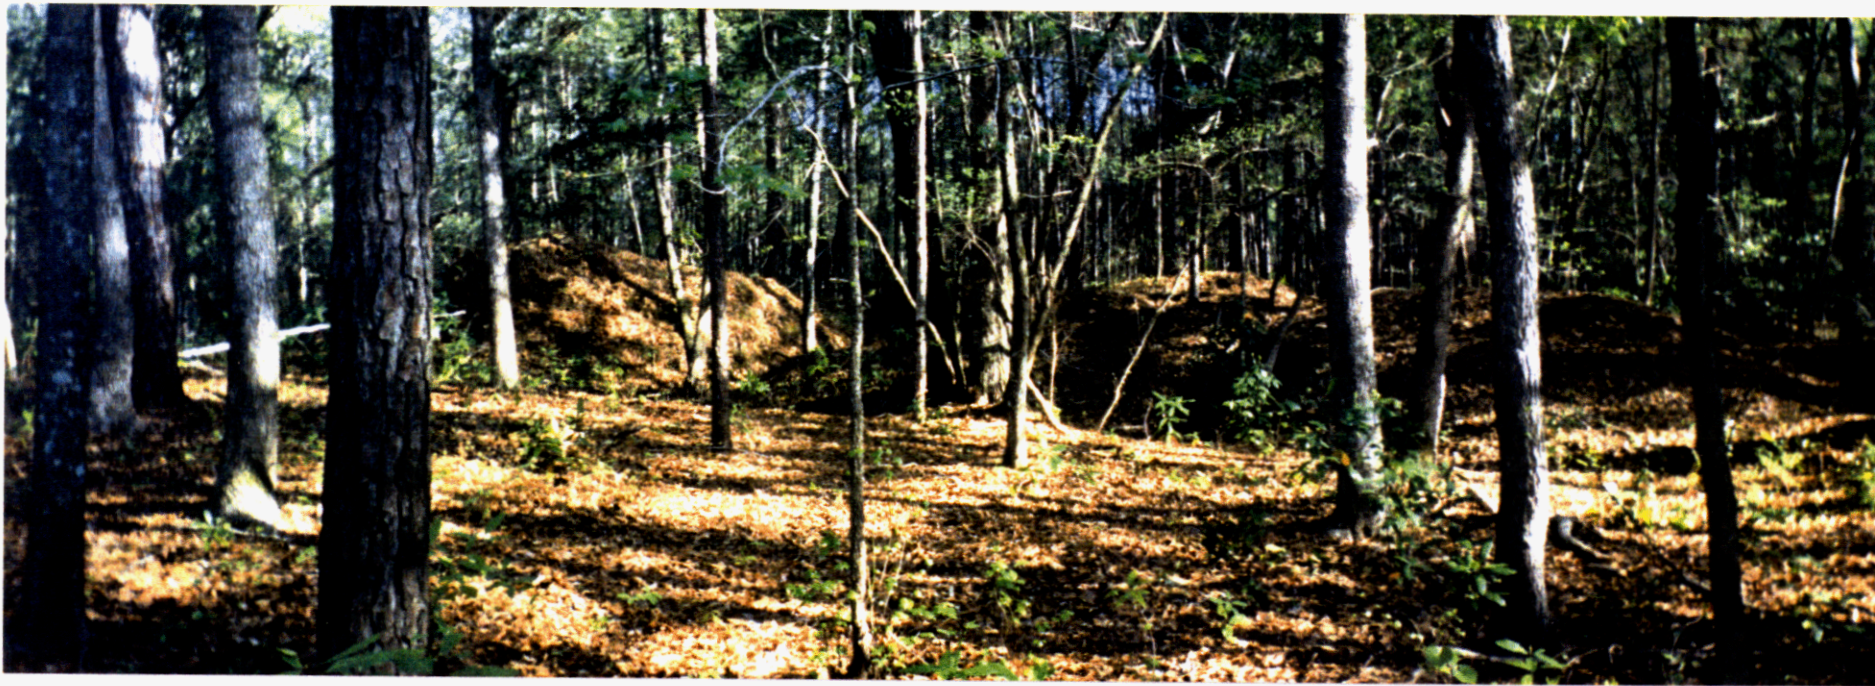
OU9.SITE65.1995.7:

Panoramic photograph from the heavy equipment trail of the southern-most debris piles. View is facing northwest. Access trail pictured in the previous photograph is to the right of this view.

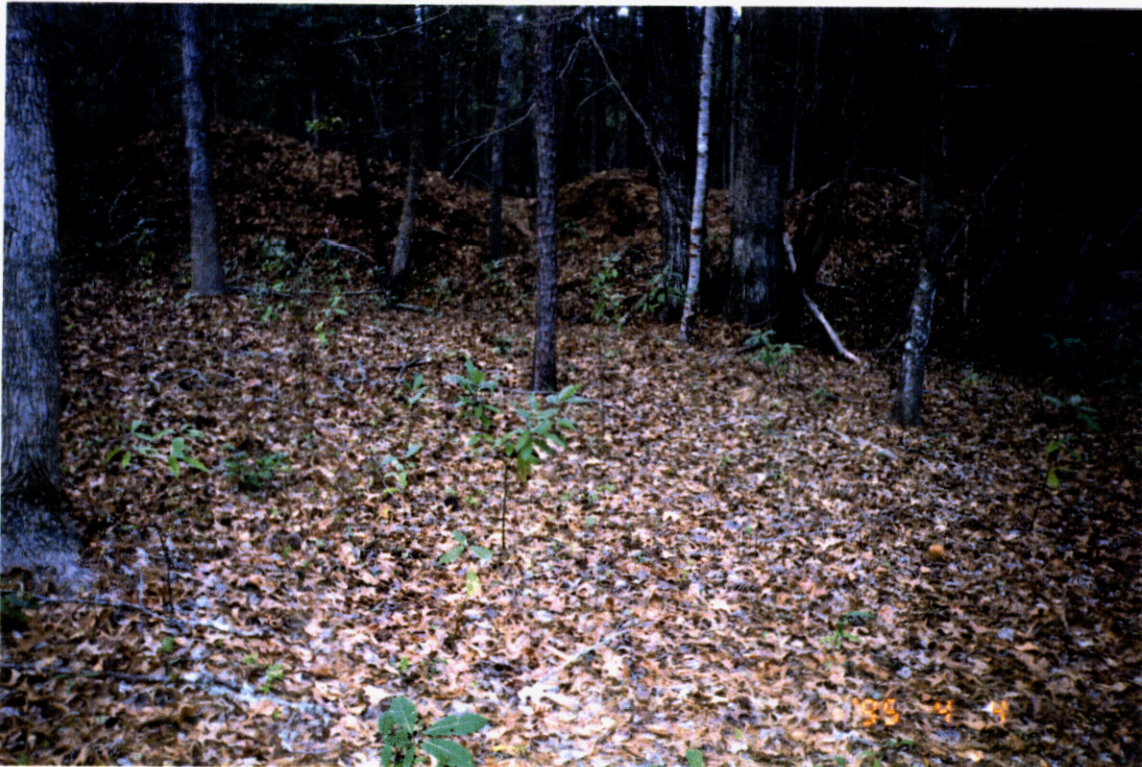
OU9.SITE65.1995.8: View of the same debris piles looking north. Photograph taken from immediately off of the northern side of the heavy equipment trail.

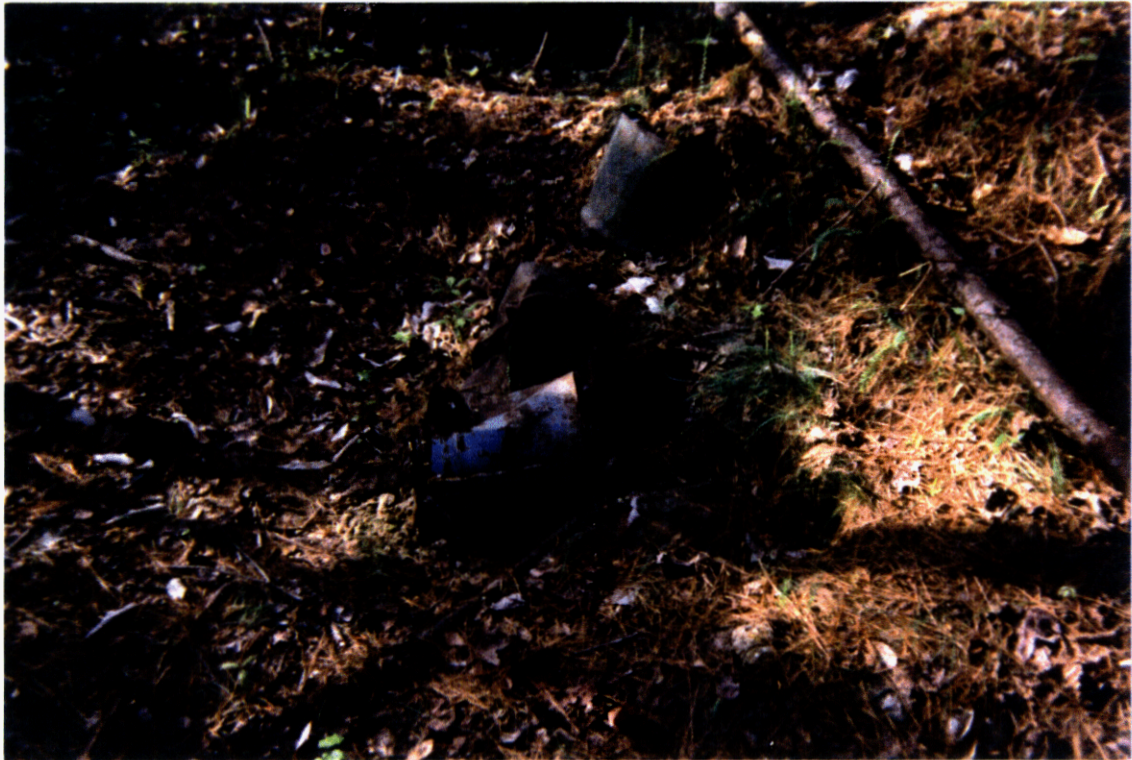
OU9.SITE65.1995.9: Photograph of metal debris associated with the southern-most debris pile of Site 65. Pictured here are heavily corroded five-gallon pails.

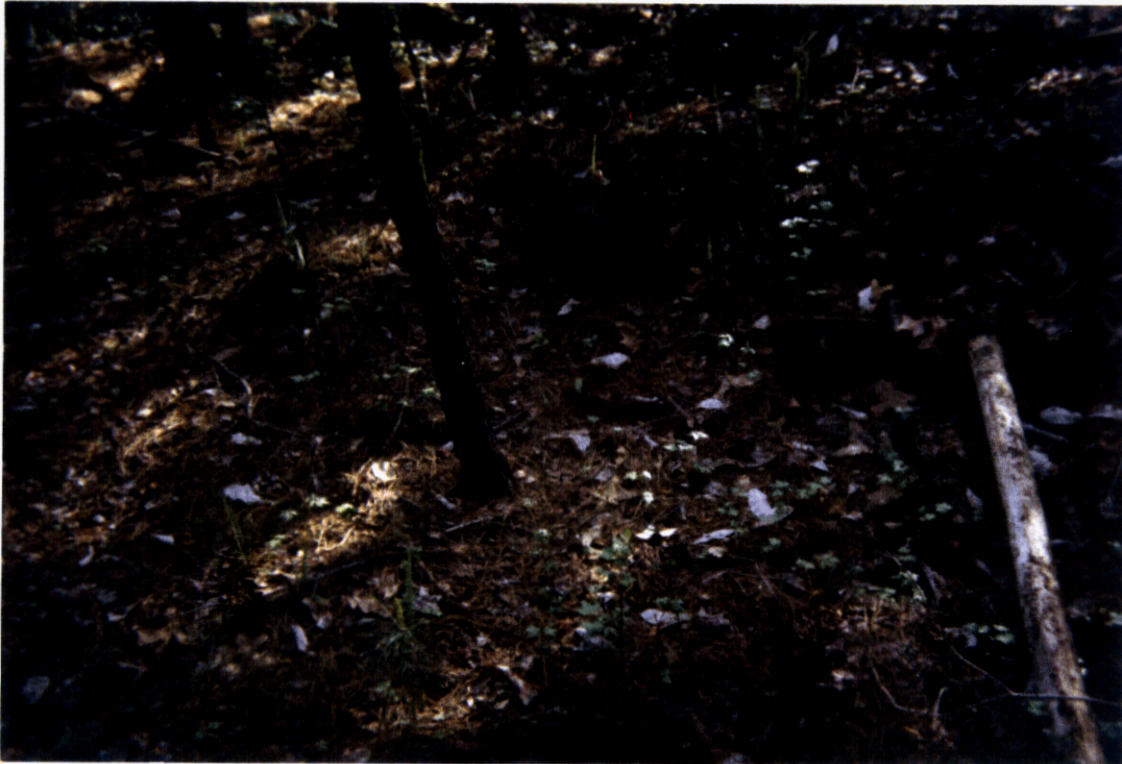
OU9.SITE65.1995.10: Another photograph of metal debris found next to the southern-most debris piles at Site 65. Pictured here is a heavily corroded 55 gallon drum.

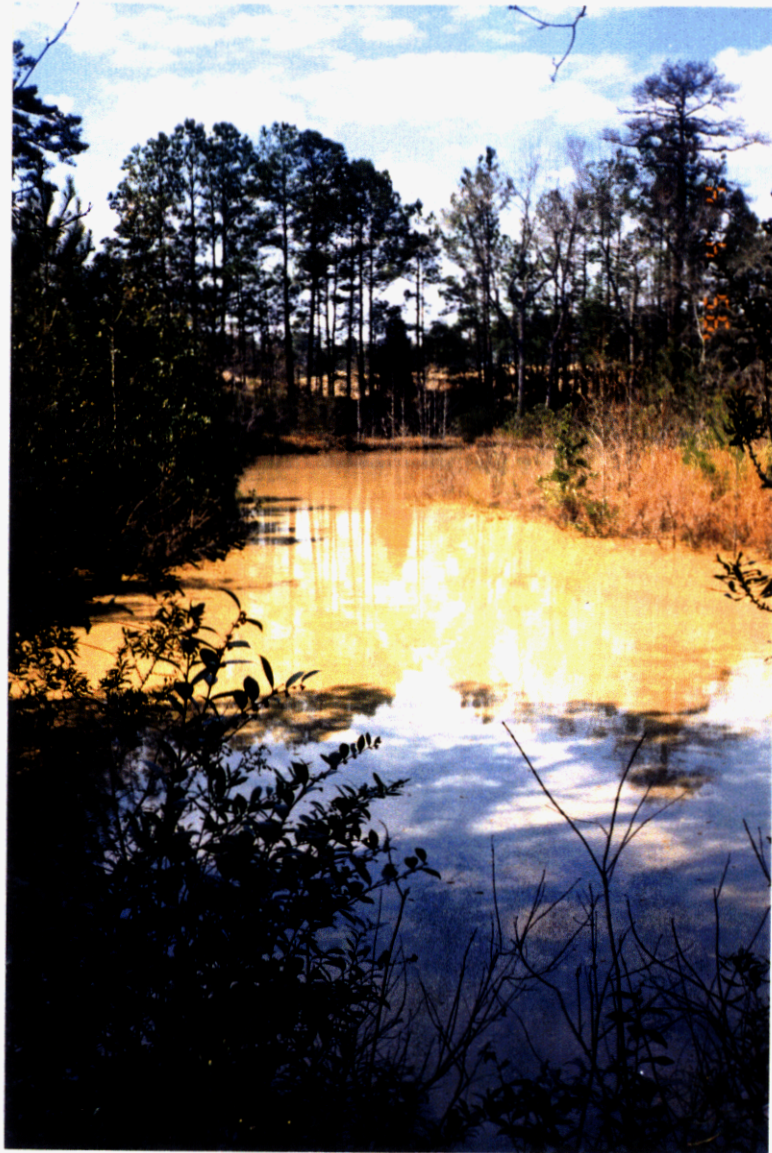
OU9.SITE65.1995.11: Photograph of one of the two ponds associated with Site 65. This pond, called Courthouse Bay Pond, is east of the engineers' training area which can be seen in the background of this photograph. The water is very turbid which is the result of runoff from the training area. View is facing west/northwest.

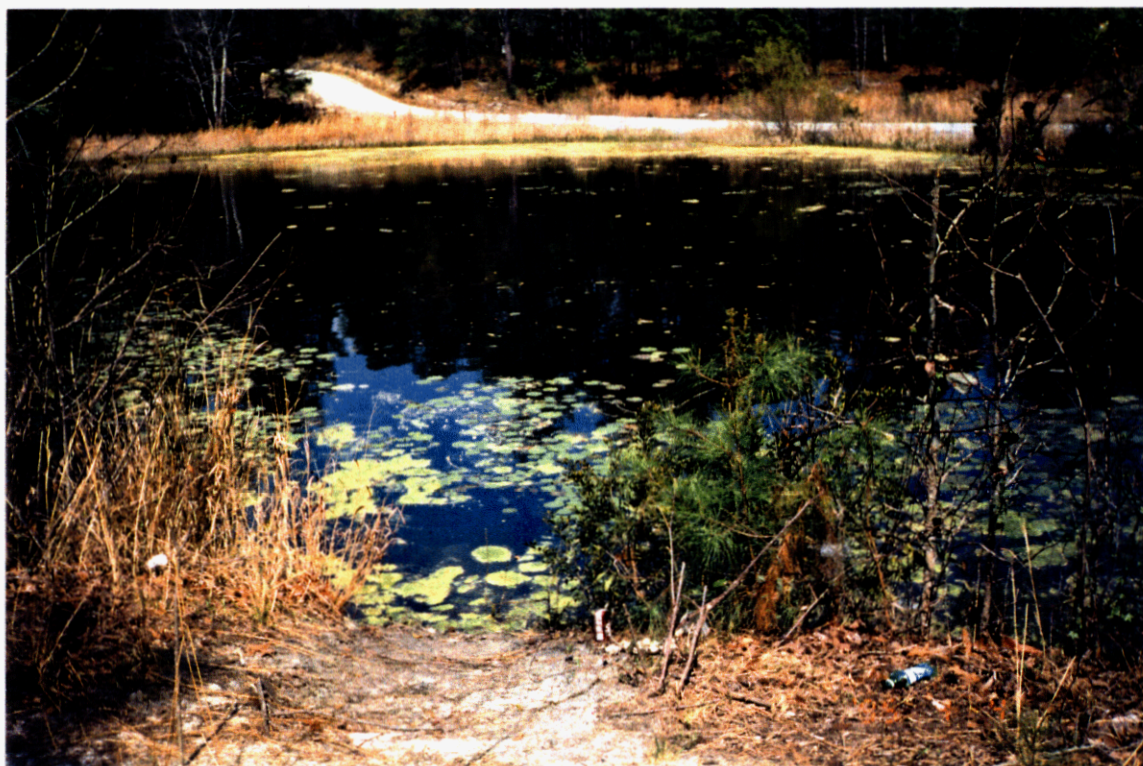
OU9.SITE65.1995.12: Photograph of the second more eastern pond associated with Site 65, named Powerline Pond. This pond is free of the heavy sediments found in Courthouse Bay Pond. View is facing northeast and the access road off of Sneads Ferry Road can be seen in the upper portion of the photograph.

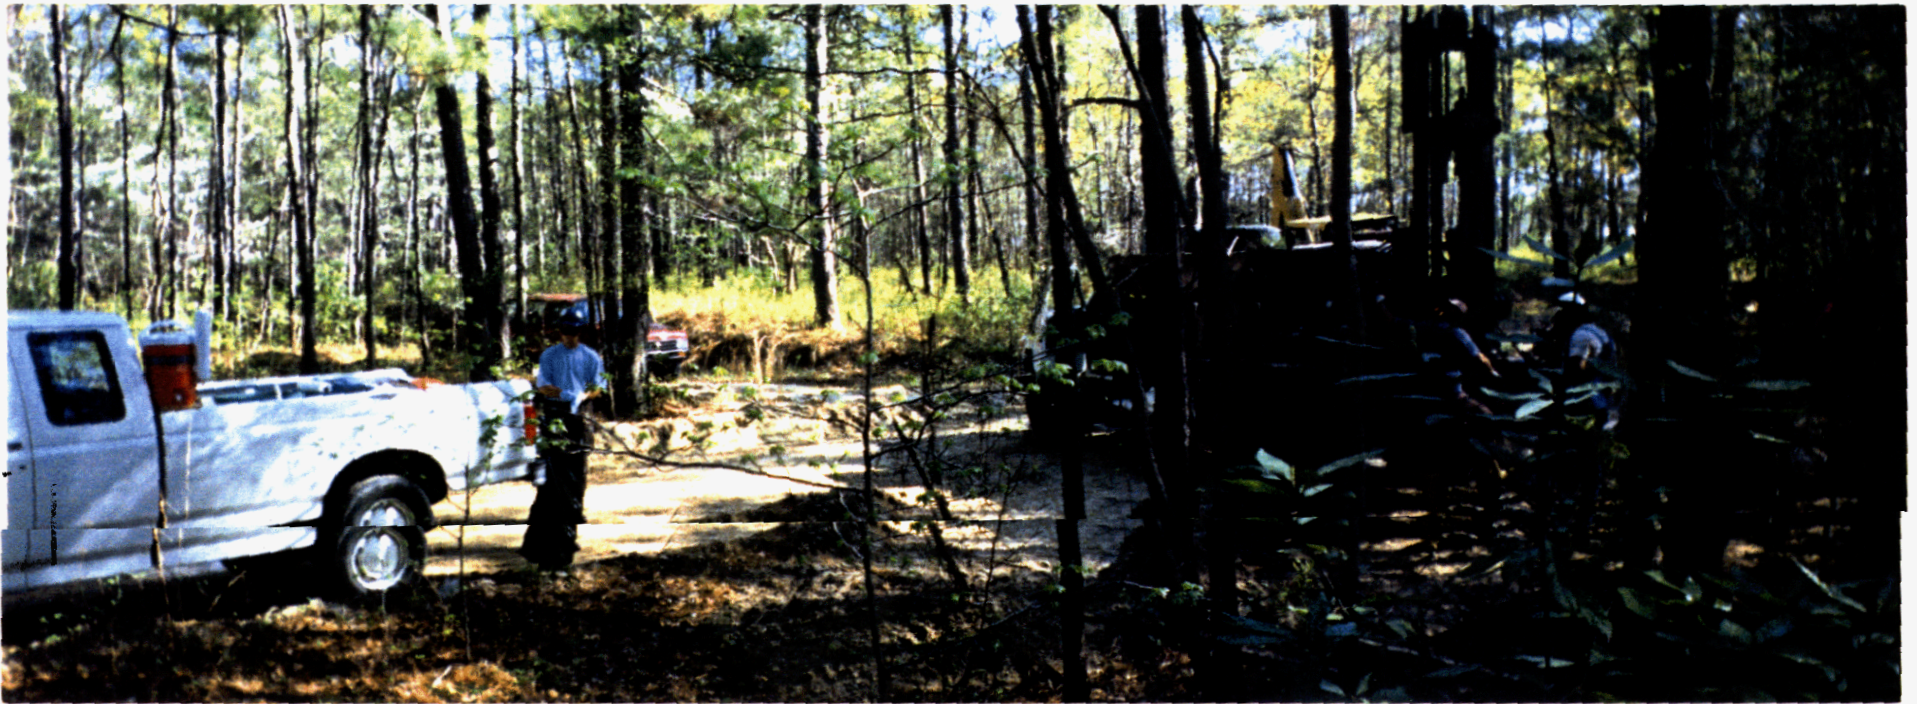
OU9.SITE65.1995.13:

Panoramic photograph of Baker and drilling subcontractor personnel installing deep monitoring well 65DW-02 with the truck mounted CME 75 drill rig. The white Baker field vehicle is situated facing west/southwest along the southern heavy equipment trail leading through Site 65 towards Courthouse Bay and the Engineering School. The photograph is taken facing north.

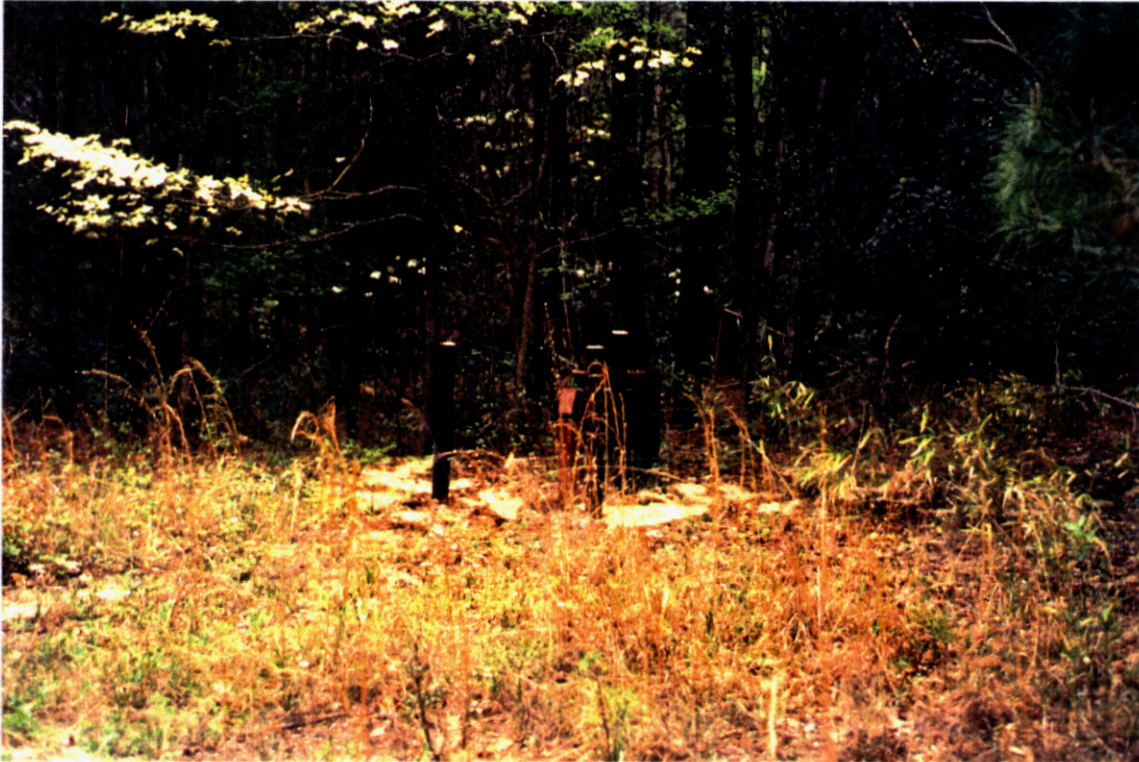
OU9.SITE65.1994.14: Photograph of the existing monitoring well, 65MW-02, which was installed during a previous investigation. This well is located next to well 65DW-02 which is pictured being installed during the remedial investigation performed in Spring 1995 in the previous photograph, No. 14. View is facing east/southeast.

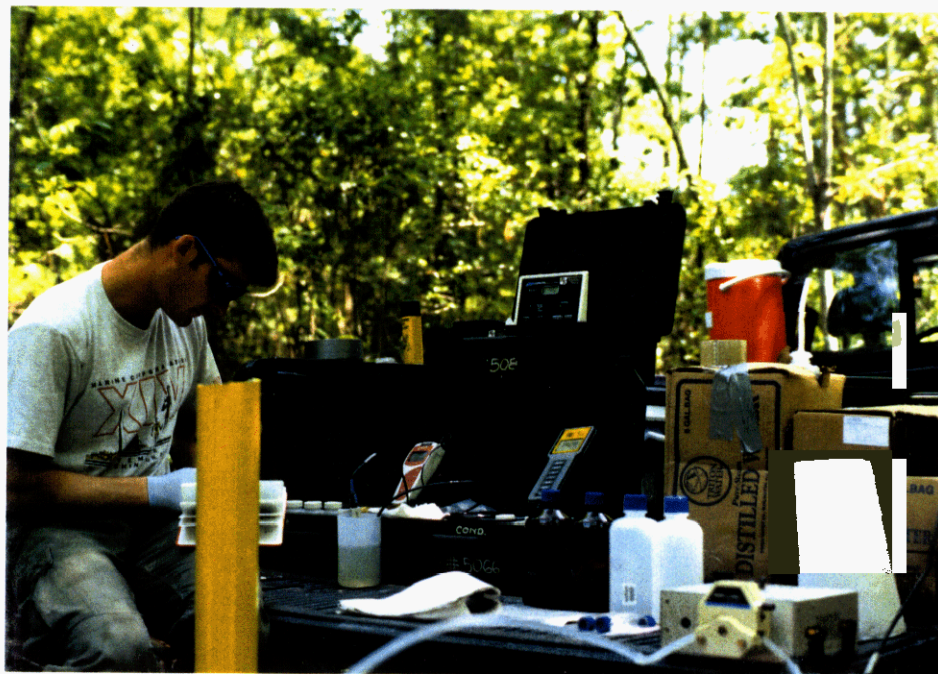
OU9.SITE65.1995.15:

Photograph of Baker personnel in the process of sampling a monitoring well. Pictured here taking measurements of groundwater pH, specific conductivity, temperature, and turbidity to determine well stability before sampling.

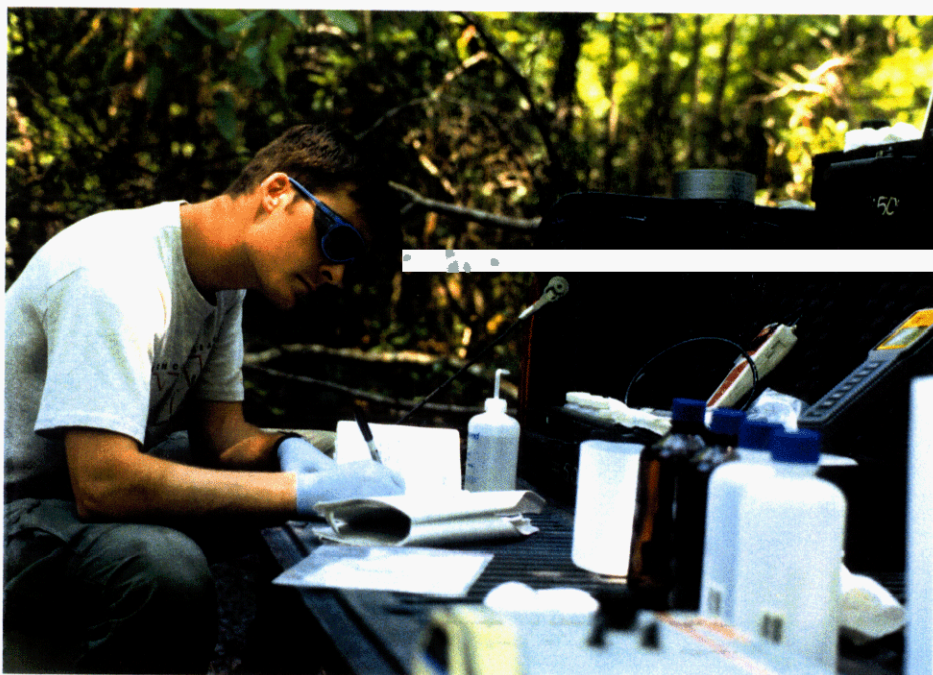
OU9.SITE65.1995.16:

Photograph of Baker personnel filling out sample bottle labels just prior to sampling a groundwater monitoring well.

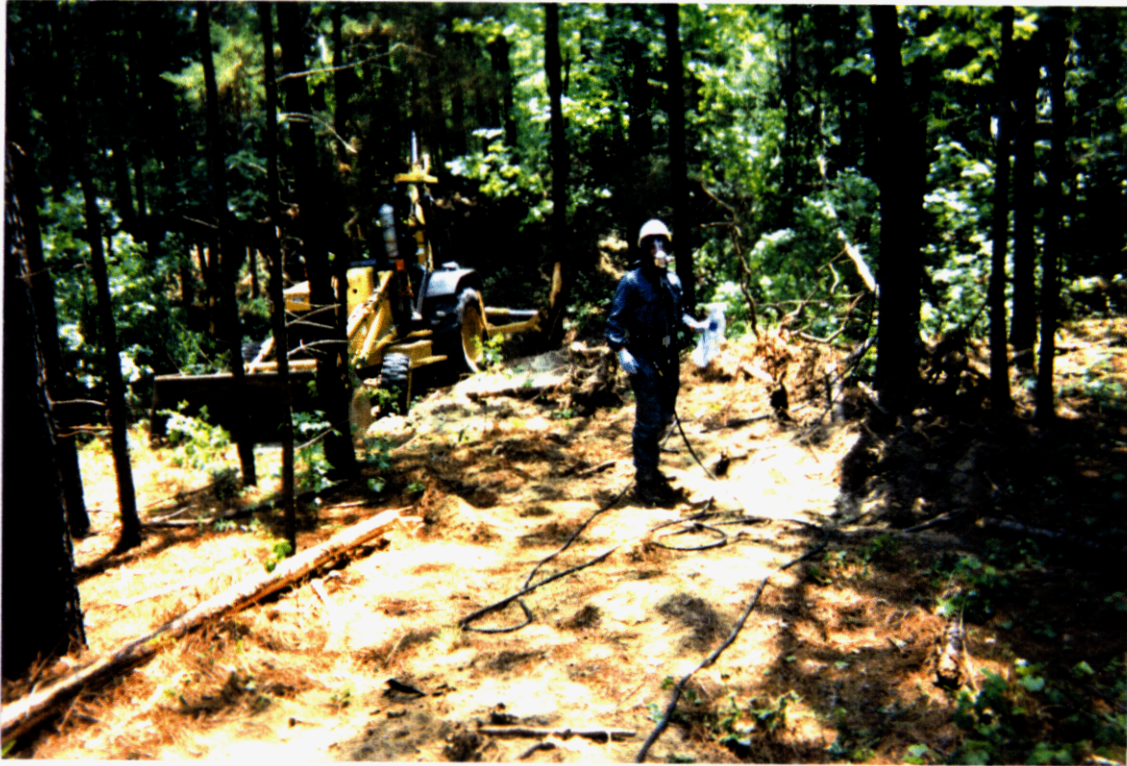
OU9.SITE65.1995.17: Photograph of Baker personnel in Level B during test pit operations at 65TP-05, located adjacent to the main debris piles at Site 65. Baker personnel pictured just prior to re-entering the hot zone. The Ford 555D is seen set up on 65TP-05 in the background. View facing approximately southwest.

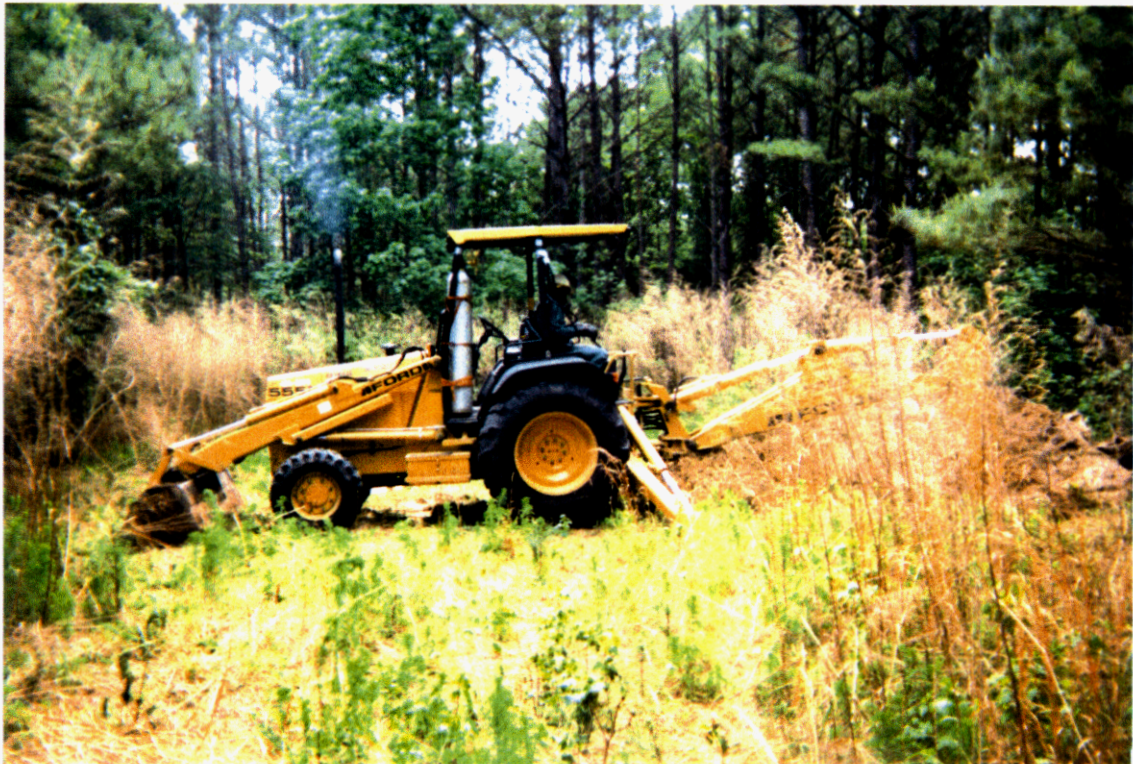
OU9.SITE65.1995.18: Photograph of drilling subcontractor personnel excavating a test pit in the burn area, 65TP-07, using a FORD 555D backhoe. Backhoe operator is seen wearing Level B protective equipment with his air tank secured in the cab space of the backhoe. View is facing southeast.

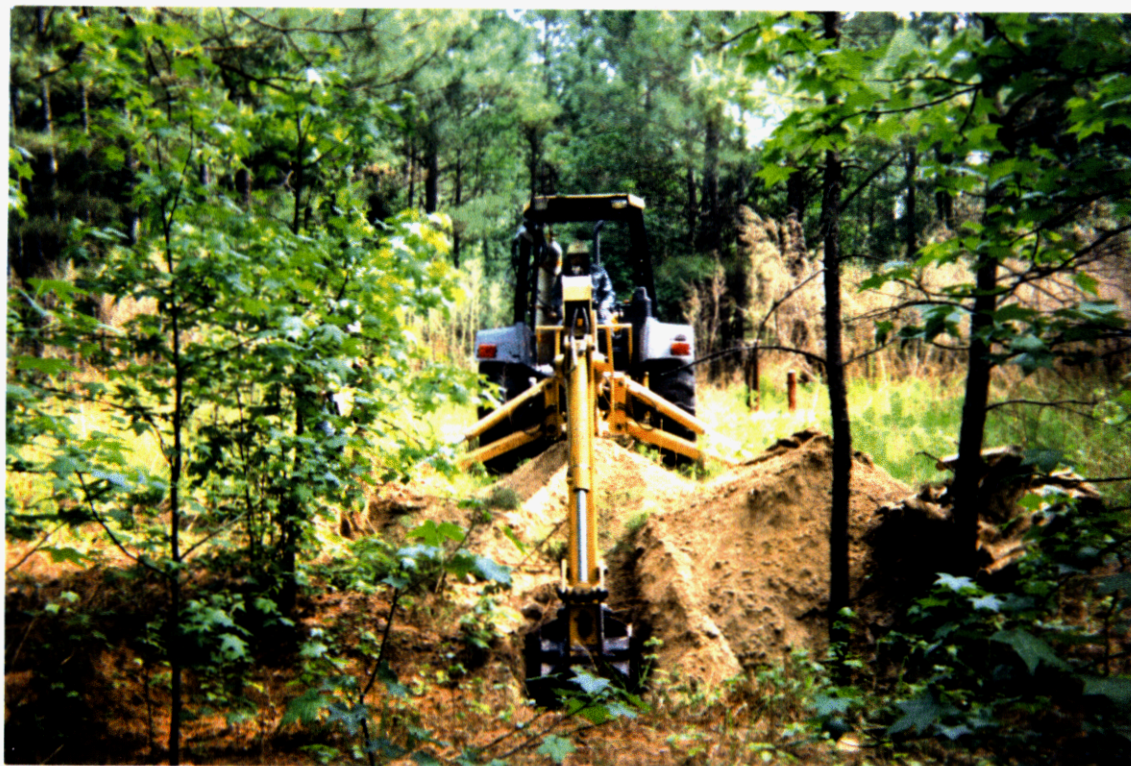
OU9.SITE65.1995.19: Another photograph of drilling subcontractor personnel excavating a test pit in the burn area, 65TP-07. Test pits were excavated to a depth of ten feet or until intercepting the groundwater table, whichever came first. View is facing approximately north with the previously existing monitoring well 65MW-01 visible to the right of the backhoe.

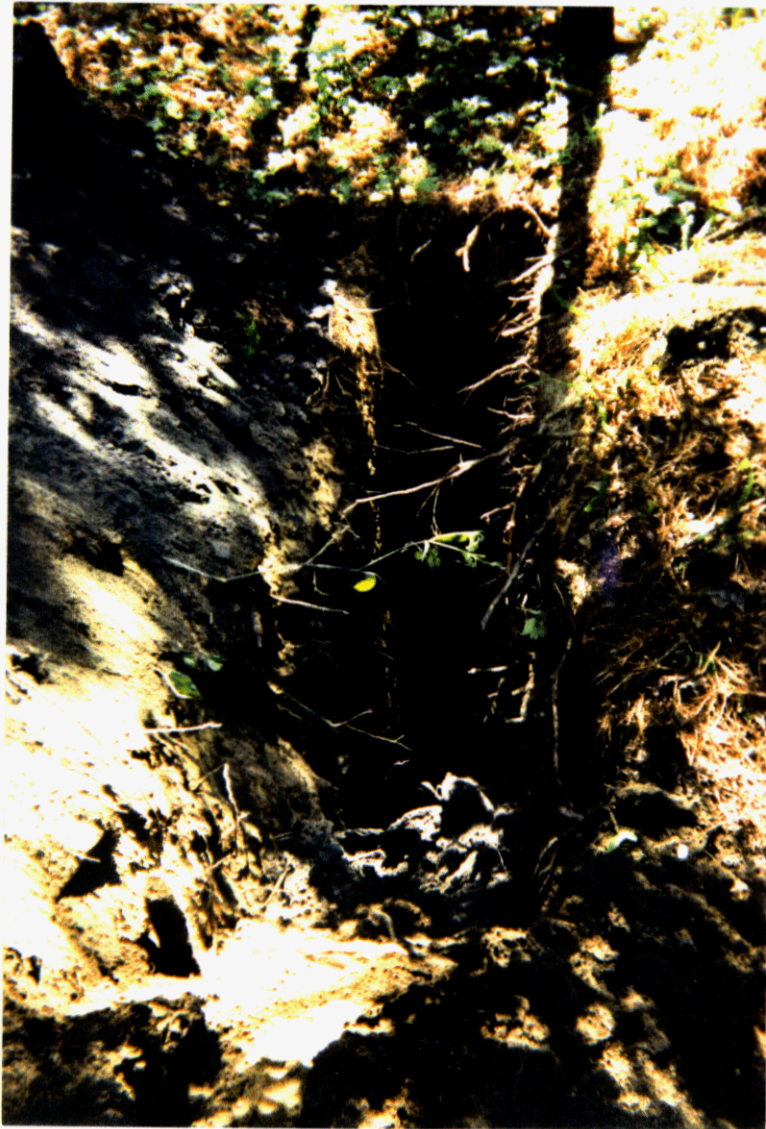
OU9.SITE65.1995.20: Photograph looking down at a completed test pit, 65TP-05. View is facing approximately southwest.

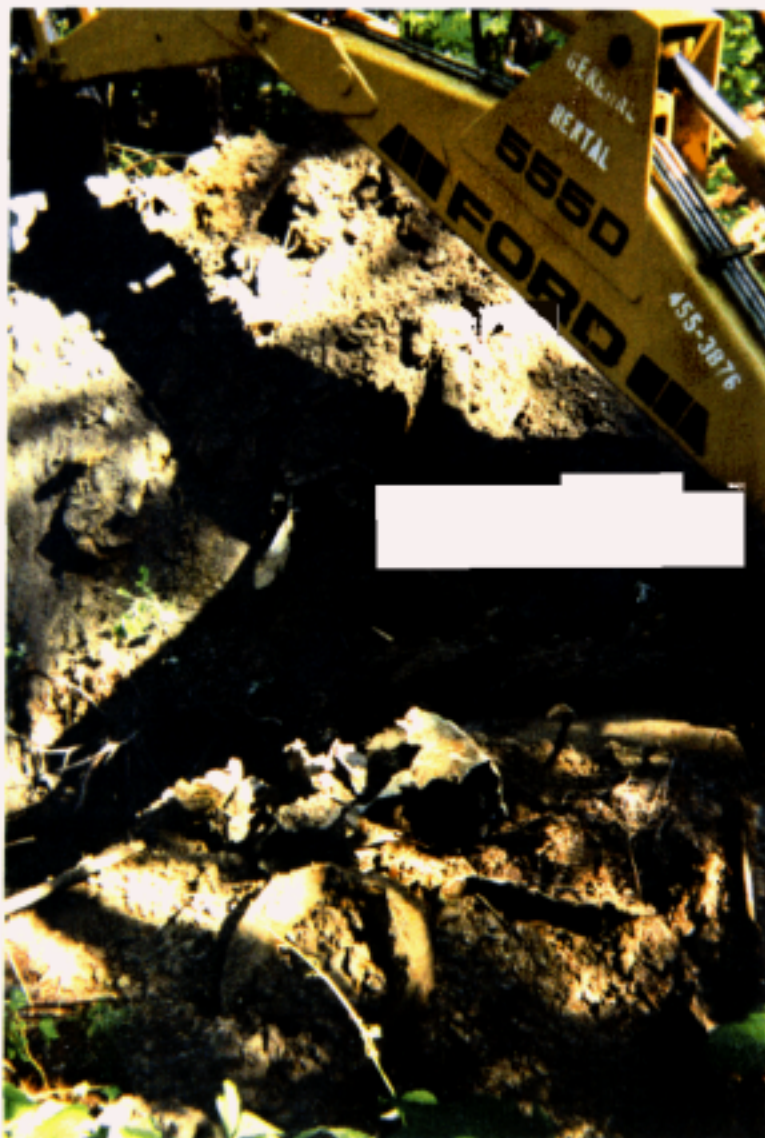
OU9.SITE65.1995.21: Photograph of test pit 65TP-04, adjacent to one of the southern-most debris piles at Site 65. Various highly corroded metal debris was encountered during excavation activities as pictured here. View is facing in a southerly direction.

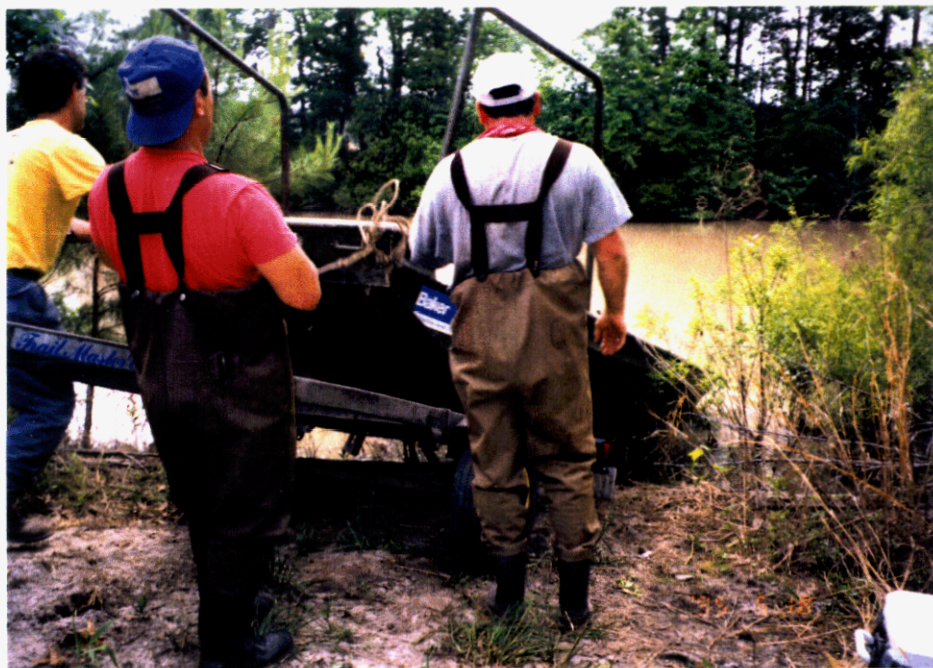
OU9.SITE65.1995.22;

Photograph of Baker personnel lowering the Baker boat into Courthouse Bay Pond, just east of the engineers' training area. View is facing west towards the training area.

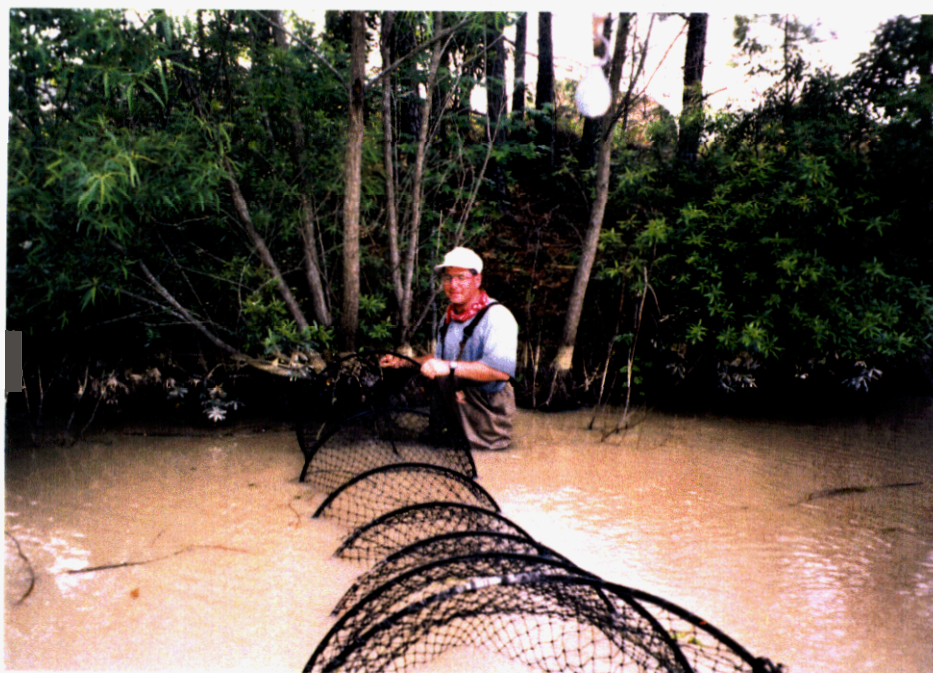
OU9.SITE65.1995.23;

Photograph of Baker personnel setting a hoop net in Courthouse Bay Pond. Note the turbid, sediment rich water.
